Letter to Editor

Malfunctioning Bain Circuit

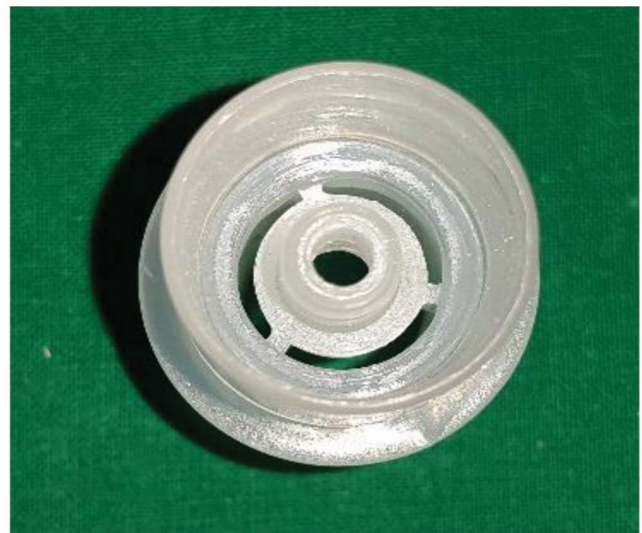
Figure 1. Photograph showing the normal connector showing patency for the inner (FGF) as well as patency for the expiratory (corrugated) tubing.

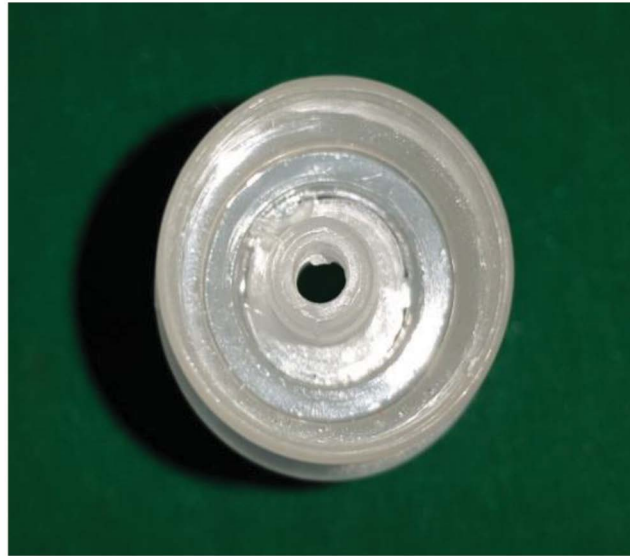
After the case in OT No. 8 got over, both the Anaesthesiologists jointly carried out the inspection of the Bain circuit. The plastic connector at the patient end was found to be defective with an obstructing thin plastic membrane (Figure 1, 2 and 3) isolating the inspiratory (inner) and expiratory (outer corrugated) limbs of the circuit, thus not allowing the expired air to enter the outer corrugated tube making IPPV impossible. Both the Bain circuits used in above cases were from the manufacturer 'Anaesthetics' Mumbai, the defective circuit of OT No. 7 was opened for use for the first time on that day without undergoing prior check by anybody. The resident posted in OT No. 7 was on emergency night duty and was busy on previous night and he did not have time to check the machine nor the breathing circuits. The consultant in OT No. 7 thought that his resident had tested every anaesthesia gadget including the Bain Circuit. However the Bain circuit of OT No. 8 had undergone prior check in the morning and was already used for two cases before being pulled out to OT No. 7.

Figure 2. Photograph showing the defective connector with patency for the inner (FGF) and non patency for the outer (corrugated) tubing.

1. *Prior checking of the circuit and anaesthetic equipment by the concerned Anaesthesiologist is mandatory for every case that is to be anaesthetised⁴.*
2. *Communication or dialogue amongst the anaesthesiologists at the earliest, about any difficulties faced in day to day working is quite essential.*
3. *Anaesthesiologist should be well versed with all the gadgets he/she uses.*
4. *Not to rely on OT Nurse or Biochemical Engineer for detection/repair of any minor defects in the gadgets.*
5. *The defect to be communicated to the manufacturer along with the photographs for immediate correction.*
